Service Advisory

Article: ASA-17-01F Date: July 21, 2017

2016 Sportsman 570 EU Quadricycle Touring Optional RH Side Panel Close Off Kit

2016–2017 SPORTSMAN EU QUAD, 570 HEAT MANAGEMENT KIT

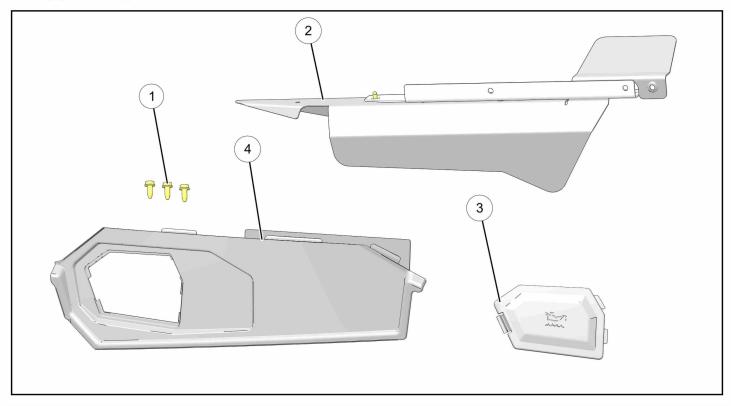
P/N 2207553

Polaris has released an optional Service Advisory ASA-17-01G for a right hand side panel close off kit that may improve a customer's riding experience under certain riding conditions. This kit specifically addresses use scenarios where riders have experienced discomfort from heat emanating from the engine compartment into the right side foot well area while operating or towing at slow speeds, even when wearing appropriate riding gear.
